## Eglinton Crosstown Elevated Guideway – Retaining Wall Toronto, Ontario

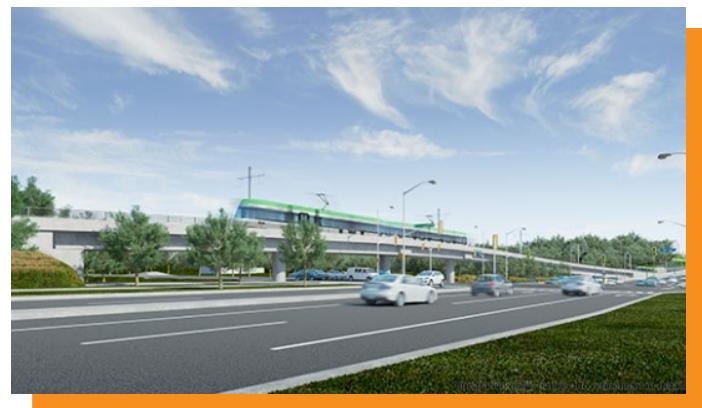
*The elevated guideway takes the trains from the east over Blackcreek drive and into Mount Denis station, the last stop before the MSF, also on GeoSolv's ground improvement systems*
