## Lockview CSO Tank St. Catharine's, Ontario

This close-quarters CSO tank with disturbed/soft soil was a significant challenge, one that GeoSolv remedied with ease and significant cost efficiencies

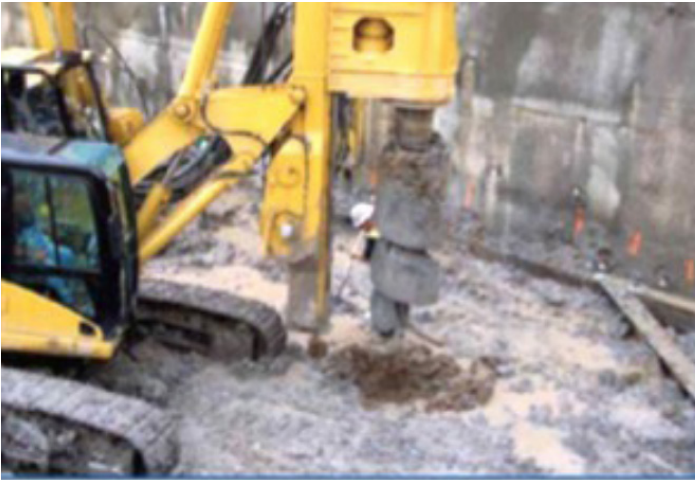
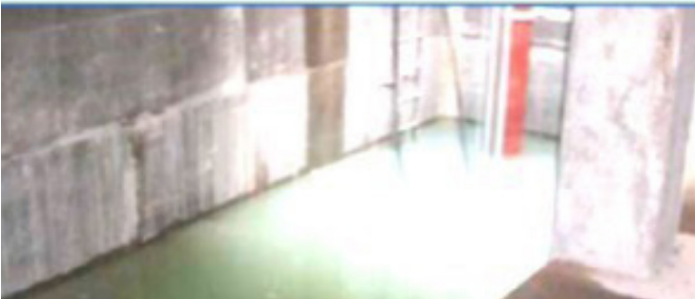
The Geopier Rammed Aggregate Pier® system was recommended to support the portion of the tank where the disturbed/soft soils had been identified and to match the portion of the tank where settlement had occurred naturally in more competent clays. The installed Rammed Aggregate Pier® (RAP) elements ranged for up to 5 meters below the ground surface. The RAP elements were installed in caving soils and in limited working space within a very deep excavation.
