Conestoga College Kitchener, Ontario

A new 2-3 storey wing at Conestoga College that was connected to an existing building to accommodate increased enrollment had subsurface conditions consisting of silty fill mixed with topsoil and amorphous peat to 4m to depth of exploration on half the site, as well as medium dense to dense sand and gravel on the other half. The dig-replace option to remove the poor fills and peat resulted in the consideration of an extremely deep excavation near the existing buildings. This option was dismissed as too costly due to the extensive shoring that would be required.

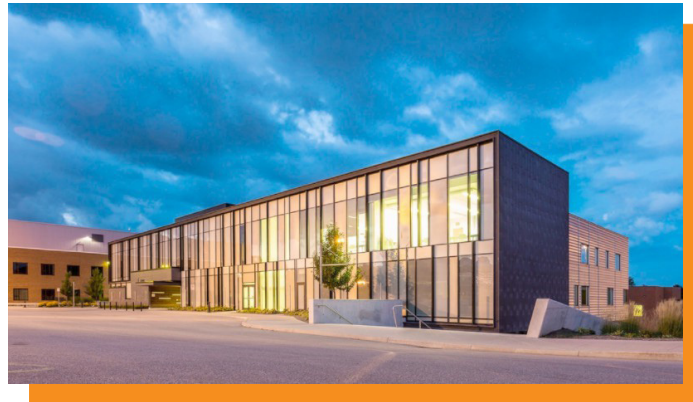
Conestoga College Institute of Technology and Advanced Learning is a public college with an enrollment of over 44,000 students. This beautiful 2 storey building rests on Geopier® elements and native ground for matched support

The Geopier Rammed Aggregate Pier® system was used to support the one half of the building, reinforcing the existing fill and peat with the other half of the structure supported on footings on good native sand/gravel. Rammed Aggregate Pier® elements presented a viable solution to support one half of the structure as the settlement control and bearing capacity of the Geopier® elements in the organics and fill was matched to that of the footings on competent native ground.
